Kumar & Associates
www.kumarusa.com

News @ K + A

January 2006

American Furniture Warehouse, Firestone, Colorado

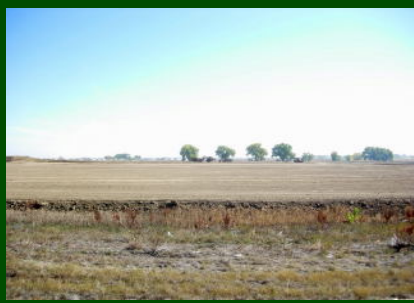
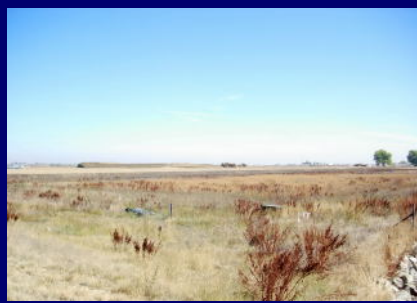
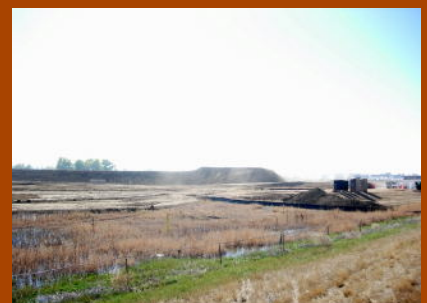
We recommended the surcharge soils be removed after approximately 8 weeks. The surcharge soils were removed and used as overlot fill in other parts of the development. A total of approximately 1 million cubic yards of fill was placed at the site. The majority of fill material was imported from a nearby aggregate pit. The photos below present a wide view of the building pad with surcharge in-place.

Due to the proposed site grading, relatively deep occurrence of bedrock and shallow ground water, spread footings were selected for support of the structure. Recommendations were presented for pre-consolidating the compressible soils by placement of a soil surcharge fill. Approximately 8 to 15 feet of soil surcharge was placed on the building pad. The depth of surcharge varied with variations in the foundation loading conditions. Temporary survey monuments were installed by K+A and were periodically monitored by a surveyor. As predicted, the monitoring indicated that most of the settlement occurred during fill placement.
